Federal Republic of Germany Tomb of Jan Baba at WHS Makli, Thatta Progress Report No - 2015/001

January, 2015

Federal Republic of Germany Tomb of Jan Baba at WHS Makli, Thatta Progress Report No - 2015/003

Progress Report No - 2015/004

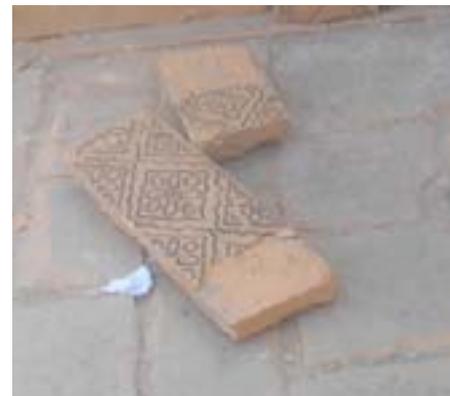
Collapsed stones from enclosure wall

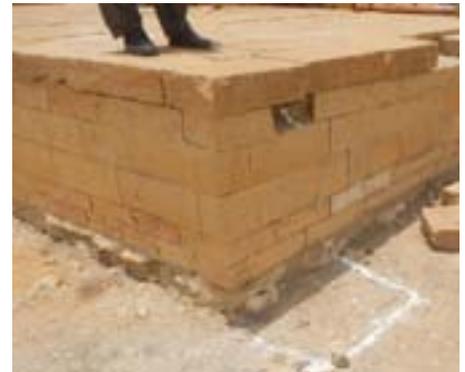
- The base or foundation stone of the plinth have become exposed in some areas, a sample was prepared for plinth protection. Two samples will be prepared, the selection will be based on the decision of the Consultative Committee.
- The cleaning of the problem areas with stone carvings with the poulticing method did not prove 100% effective, however, when combined with a small scratching tool. It was made sure that great care is taken in both soaking the stone and then lighting scratching the dirt away, that became soft after 2 hours of soaking with the poulticing method.
- A sample for Kangura has been carved out of stone. The sample needs slight improvements and then can be placed on the structure, to assess the quality and resemblance to the original.

Exposed plinth stone of Entrance platform.

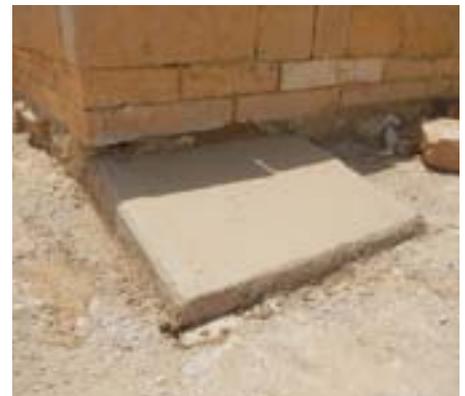
Sample 1 for Plinth Protection.

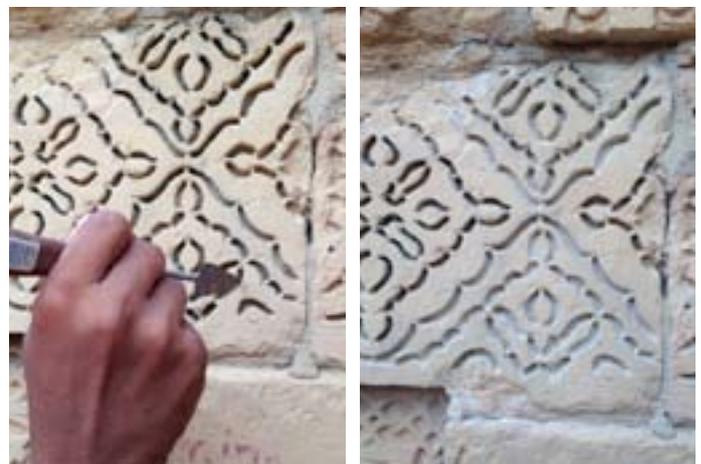
Scratching after soaking for 2 hours. Satisfactory results.

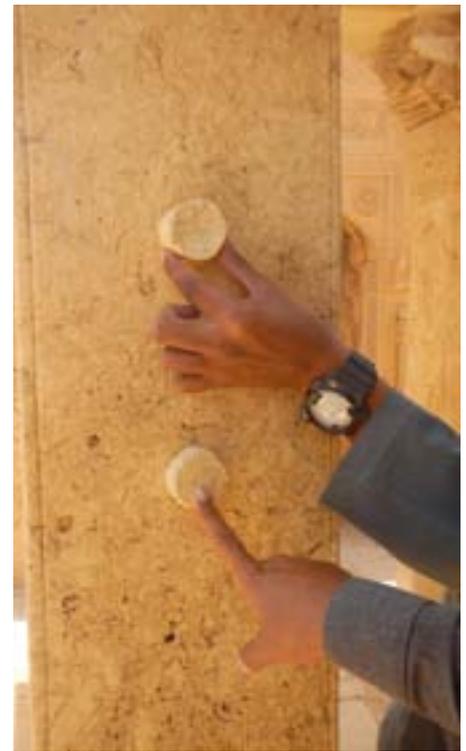
- Mortar samples were prepared to match the colour of stone for pointing of joints. The approved mortar ratio is 1:1:1:2 (Lime: Chiroli: Sand: Yellow Stone Dust).

Mortar samples for pointing.

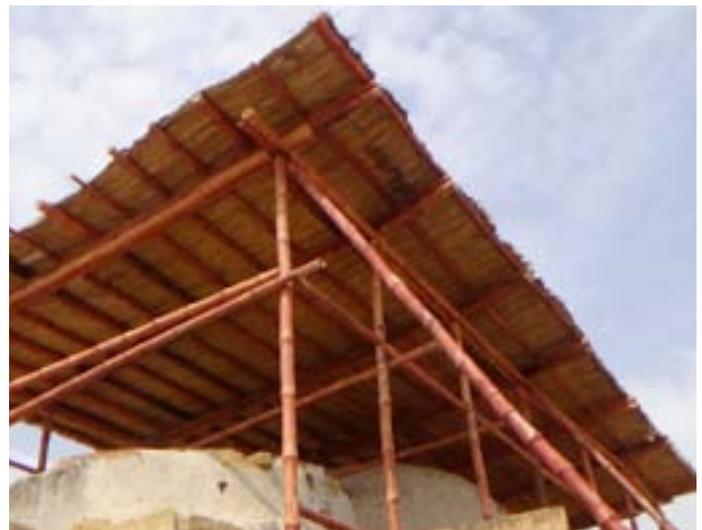
- The graves platform has been secured with a temporary bamboo roof structure. The structure provides protection from the upcoming monsoon season, it is made sure that no further damage is caused to the graves canopy. The structure has been stabilized with toe like supports at the bottom.

Temporary Roof Structure over the Domes.

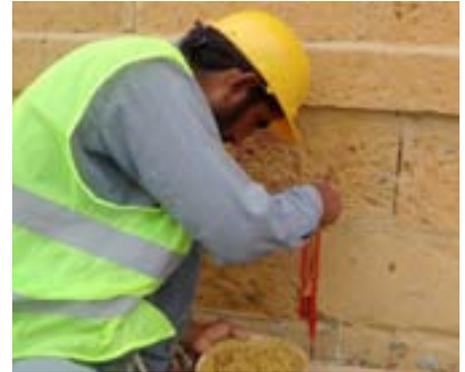
- The exterior pointing of stone joints was started after approval of the sample by the Experts Committee based on the test patches that had been prepared for this purpose. The ratio of the mortar being used is 1:1:1:2 (lime, sand, chirol, yellow stone dust)

Deep struck pointing of stone.

- Sample of deep struck re-pointing was approved to be used on joints of 1/4" to 3/8" thickness.
- The principle of minimum interventions is to be adopted; no stone replacement to be carried out.

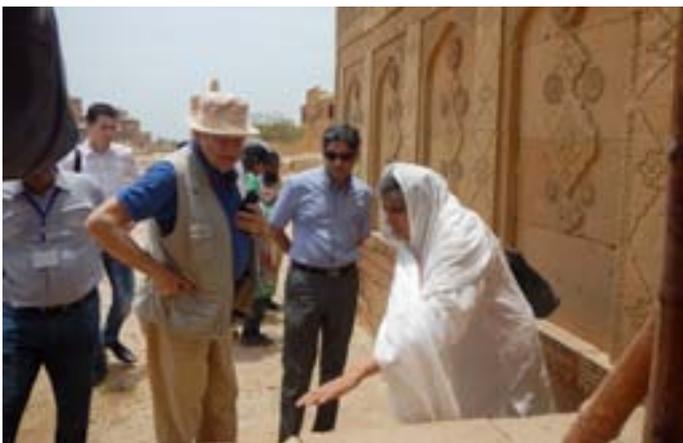
Discussion on treatment of damaged stone steps.

- For the damaged stone at the steps wooden nosing may be used.
- Where possible remove cement used earlier for surface repair on columns. At highly damaged surfaces of columns matching mixture of mud and lime may be used.

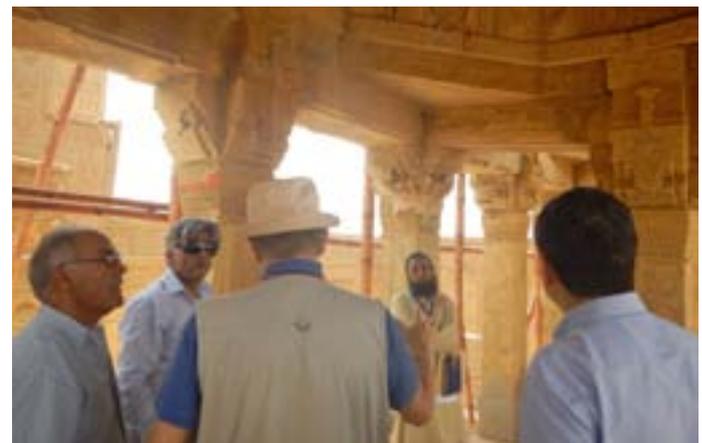
Examining the settlement of columns and central dome.

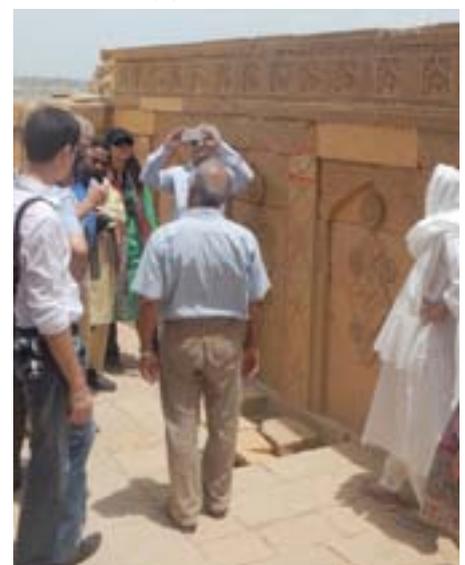
Damaged floor stones under discussion.

- Floor stone slabs in the enclosure and the grave canopy may be re-laid in order to ensure effective drainage.
- Because of the centrality of the entrance and lack of any access from the south side, wooden step may be added.

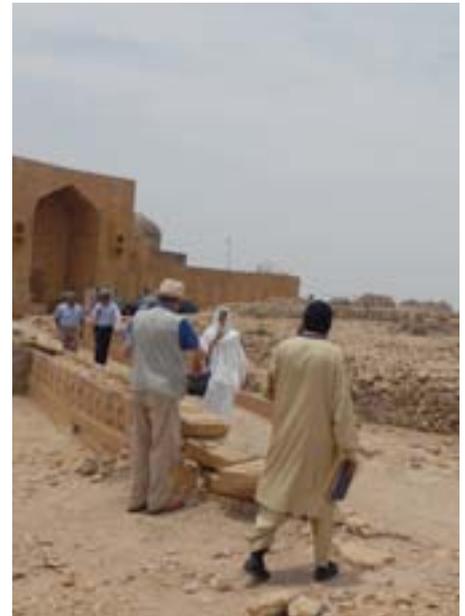
Loss of stones of the walkway being examined.

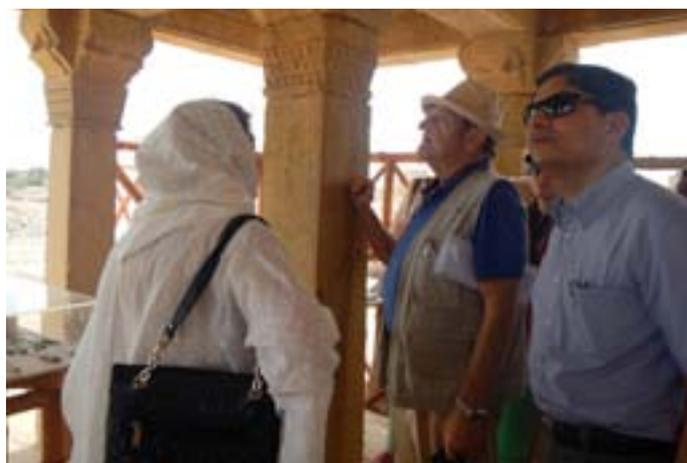
Examining the soffit of stone slabs in the entrance canopy.

- Matching lime sand water proof layer to be applied to damaged surfaces of stones above the entrance canopy. Proper drainage should be maintained to discharge on east side.

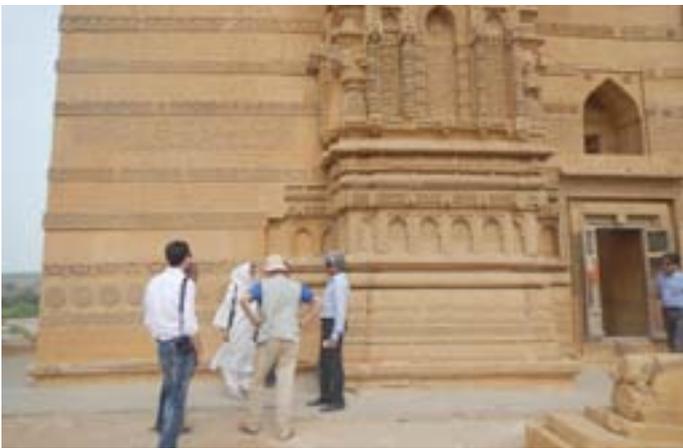
The engineering experts explained that the ridge required stabilization and it was constantly being eroded. Unless immediate action was taken, many structures, including the tomb of Jam Nizam al-Din were in danger.

Experts discussing the cracks appearing in tomb of Jam Nizam al-Din

Ar. Yasmeeen Lari agreed to get track monitors installed in order to monitor the movement in the structure, which she directed will be done in the subsequent week.

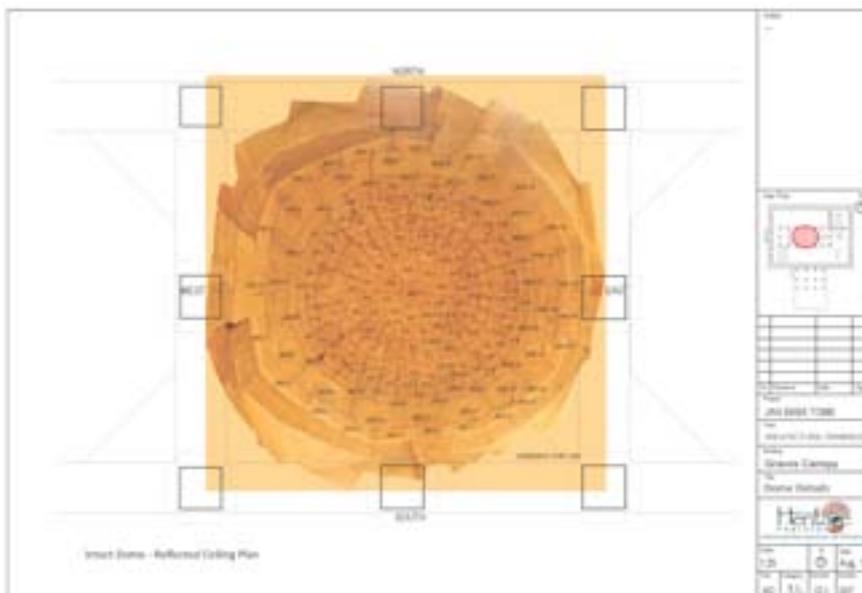
As highlighted in various reports prepared by HF, the central dome was in a highly vulnerable condition and it was agreed that it needed to be stabilized urgently. The Experts' Committee provided clear directions to maintain the original structure even though deformation had taken place within the dome structure as well as supporting stone joists and pillars. It was agreed that after stabilizing the dome, regular monitoring should be carried out in order to determine any movement in the structure.

Record of condition of dome before treatment and numbering of stones.

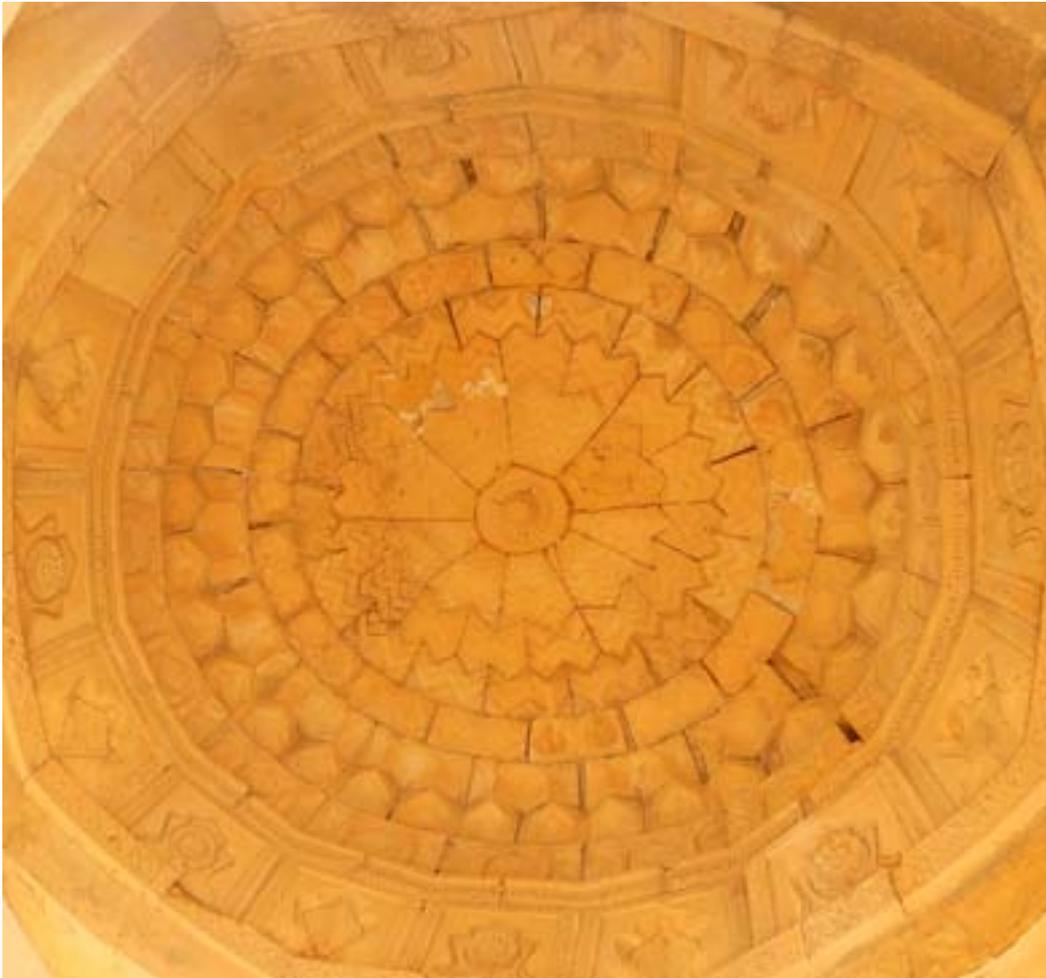
Before conservation - Reflected ceiling view of middle dome.

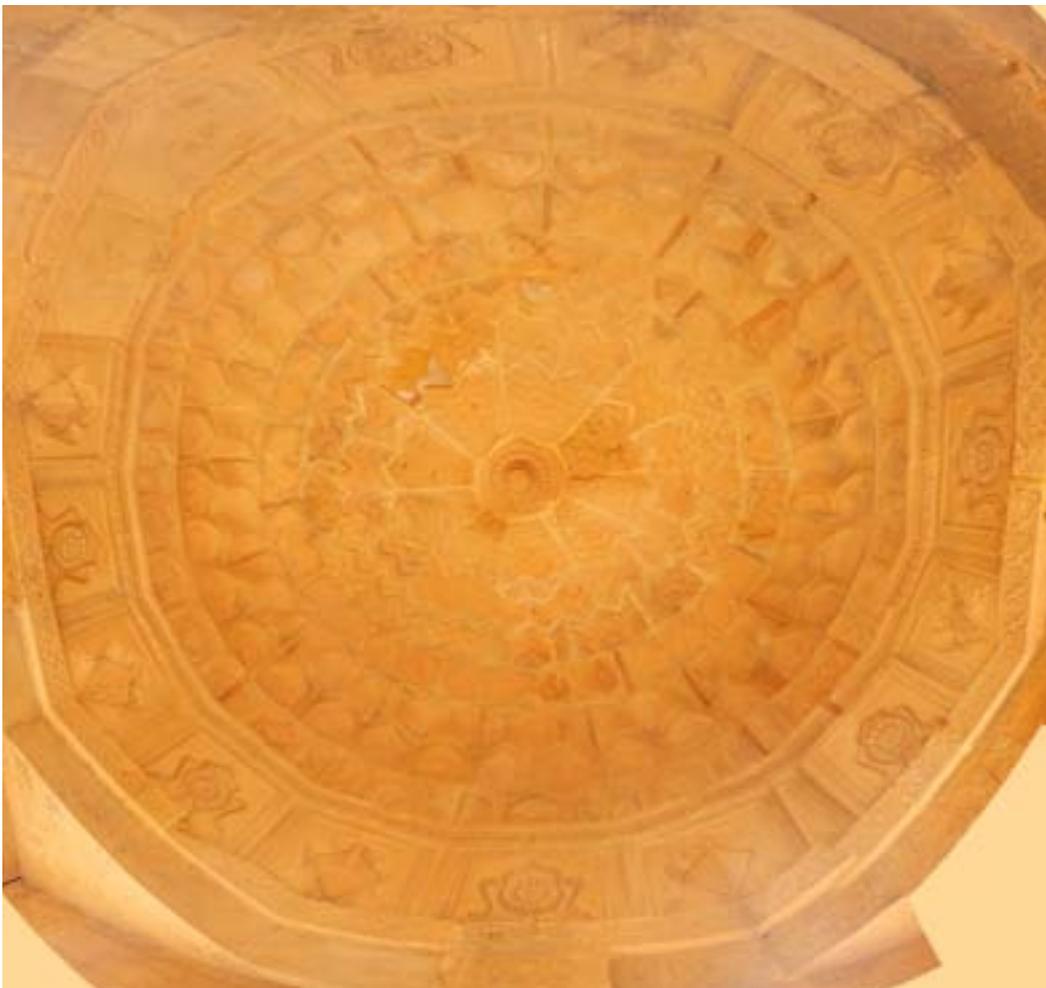
After conservation - Reflected ceiling view of middle dome.

As a result of the foregoing discussion, the decision of utilizing terracotta/brick pieces to treat the wide joints was adopted, which conformed to the following conservation concerns:

- By using brick the difference of material along with its different color will conveniently mark the new conservation work, with 2015 marked in an unobtrusive manner on one of the brick insertions.
- The workability of brick is easier than the stone and the skilled master artisans available with HF will be able to carve the brick into the required shape on site.
- This material will be stronger than mortar and less likely to develop cracks upon any movement / settlement.
- The brick will not be as strong as the original material (stone) as is preferred for new conservation work.
- The weight of brick will be less than the stone filling and hence no extra weight will be put on the dome.
