SETHI HOUSE, PESHAWAR

CONSTRUCTION RECORD

CONSERVATION RECORD DOCUMENT
Preventive Conservation / Conservation Works

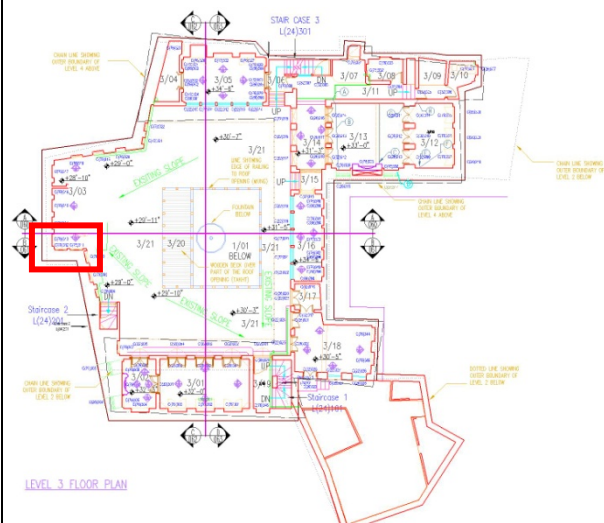
Vertical cracks were found in the South West corner of Demolished room 3/03 and were necessary to repair the h'rrary Project Director allowed to do the same.

Title of Works:
Cracks Filling

2.4 Specification of Materials
Gypsum + Lime Water

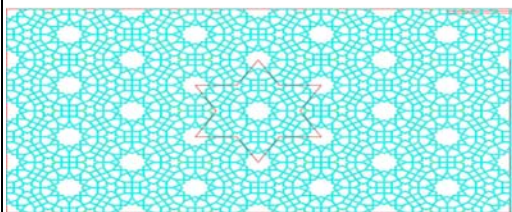
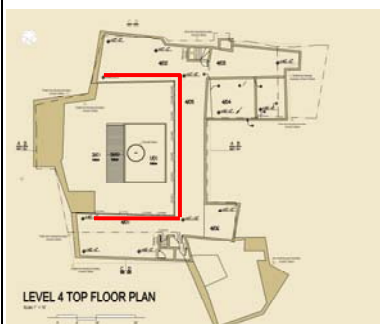
2.2 Drawings

4/05 Original Railing not aligned, or Strong enough for support.
3/21: Removing of mud from roof.

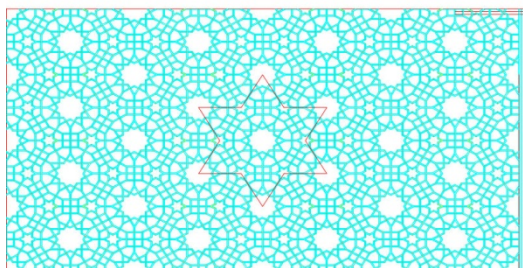
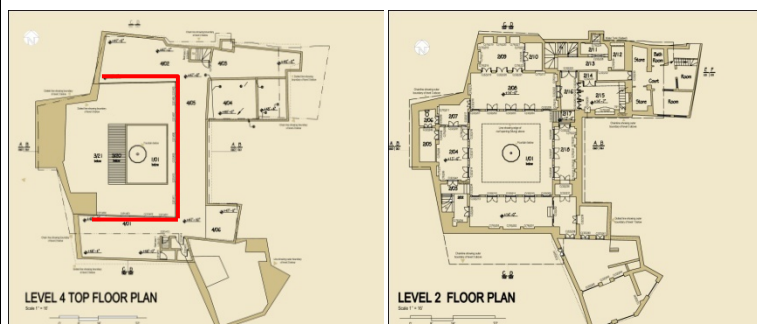
2.2 Drawings

After removing layers of existing roof 3/03 necessary to construct the roof according to set pattern
Original Railing of roof 4/01, 4/02 and 4/05 not aligned, or Strong enough for support.
Tarseem Bandi 2/09 missing in portions.

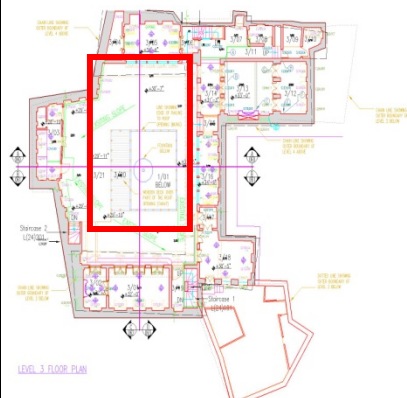
3/03 Laying New Wooden Planks as original were missing or severely damaged.
Termite Proofing 3 Coats on both rafters and planks.
Layer Cold Bitumen and Polythene for Water Proofing. Pouring Course of Lime-Aggregate Mix Maintaining 1:10 slope thus defining new drainage point as shown on drawing below (blue).

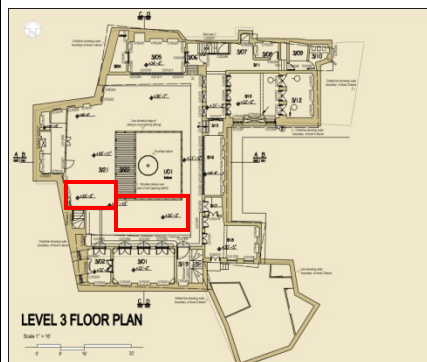
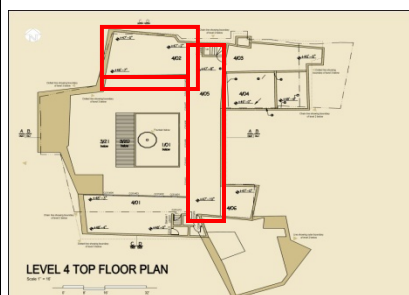
2.2 Drawings

3/21: Removing mud layers to reduce Load. Brick masonry to complete the missing Lower portion of a corner of the wall in lime mortar. Removed the dilapidated rafters in front of Western stair case for replacement. Fill the cracks in the newly built layer of kankar coarse lime.
4/02;4/05 Beams being prepared and fixed for railings. Cleaned the area and apply bitumen layer 1mm cold.

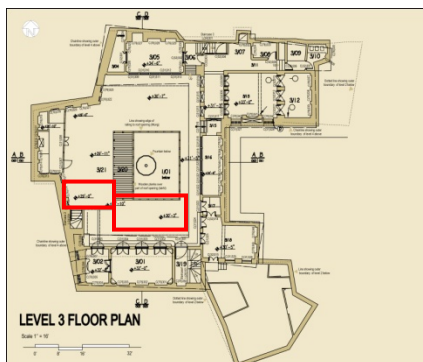
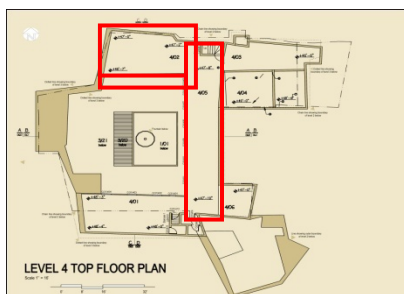
2.2 Drawings

3/21: Removing mud layers to reduce Load. Brick masonry to construct the roof Western stair case and placed batons , capped with Deodar planks, applied termite repellent 3coats, 1mm bitumen layer and kankar coarse Lime.
4/02: Lime mortar layer to fill the gaps in between brick tiles for water tightening,
4/05: : Spread Jumbo Ion and Started laying Brick Tiles Layer.

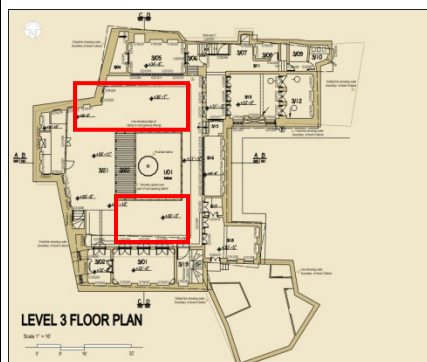
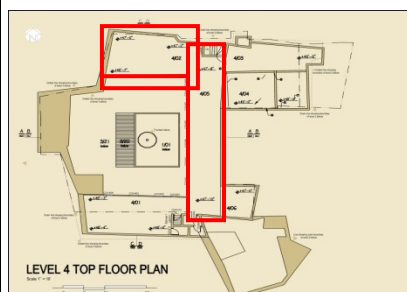
2.2 Drawings

3/21: Removing mud layers to reduce Load. Brick masonry to construct the roof Western stair case and placed batons , capped with Deodar planks, applied termite repellent 3coats, 1mm bitumen layer and kankar coarse Lime.
4/05: Lime mortar layer to fill the gaps in between brick tiles for water tightening,

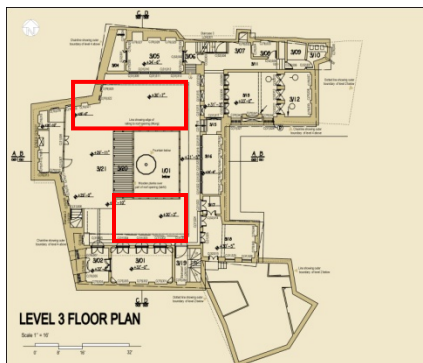
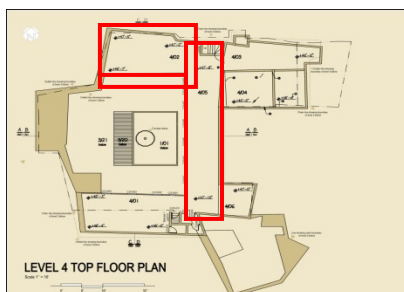
2.2 Drawings

2/09: Fixing of new wooden pieces with Terseem Bandi to complete the missing portion.
3/01: Scrapping of doors to remove paint layers and to expose the original layer of wood.
3/21B: Cleaning, Capping the spaces in-between the rafters with bricks 2"x4"x8" and 0.75" new deodar wooden planks And pouring of kankar lime mix aggregate. 1:2:4.
3/21C: Removing of layers from the roof, 2" brick, lime mortar 2", mud layers. 10".
4/01&4/05: Dismounted railing is under the finishing process. Removing the a thin layer to make the surface plane, Re-sizing, patch work, Finishing.

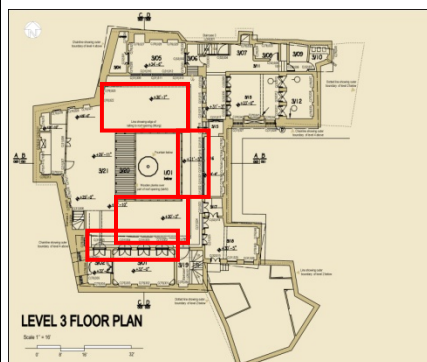
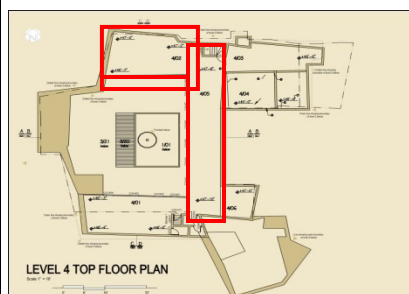
2.2 Drawings

2/09: Preparation of wood pieces to complete the Terseem Bandi in missing portion.
3/01: Scrapping of doors to remove paint layers and to expose the original layer of wood.
3/21B: 2/3 of the roof was completed last night and the remaining portion of the roof was completed.
3/21C&D: Removing of layers from the roof, 2" brick, lime mortar 2", mud layers. 10".
4/01&4/05: Dismounted railing is under the finishing process. Removing the a thin layer to make the surface plane, Re-sizing, patch work, Finishing and preparing the sample of louver to fill the spaces in-between the windows.

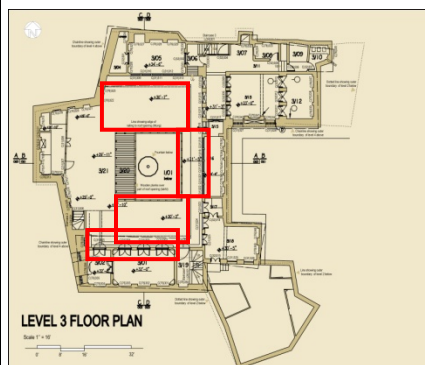
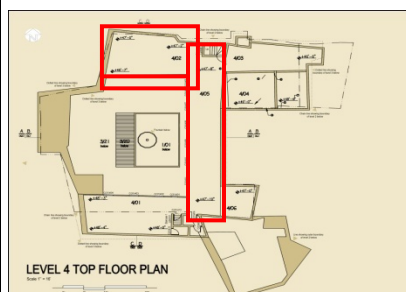
2.2 Drawings

2/09: Preparation of wood pieces to complete the Terseem Bandi in missing portion.
3/01: Scrapping of doors to remove paint layers and to expose the original layer of wood.
3/21B: 2/3 of the roof was completed last night and the remaining portion of the roof was completed.
3/21C&D: Removing of layers from the roof, 2" brick, lime mortar 2", mud layers. 10".
4/01&4/05: Dismounted railing is under the finishing process. Removing the a thin layer to make the surface plane, Re-sizing, patch work, Finishing and preparing the sample of louver to fill the spaces in-between the windows.

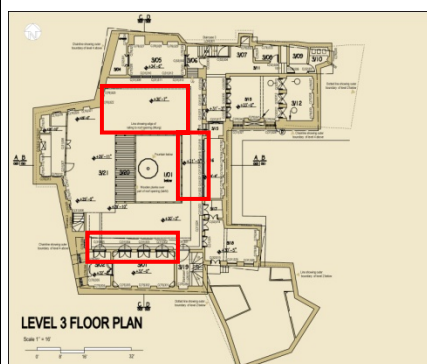
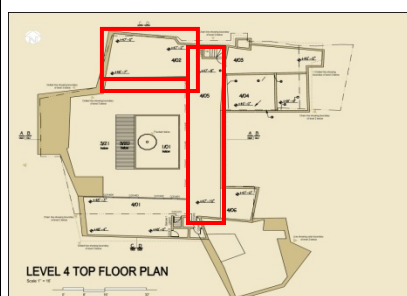
2.2 Drawings

2/09: Fixing of wood pieces to complete the Terseem Bandi in missing portion.
3/01: Scrapping of doors to remove paint layers and to expose the original layer of wood.
3/21C&D: Removing of layers from the roof, 2" brick, lime mortar 2", mud layers. 10" in part D and after cleaning applied Anti-termite, bricks, polyethylene sheet and lime mortar layers in the part C.
4/01&4/05: Top wood beam erected and finishing treatment to the newly constructed ghalta. Removing the a thin layer Of the dismantled railing to make the surface plane, Re-sizing, patch work, Finishing and preparing the sample of louver to fill the spaces in-between the windows.

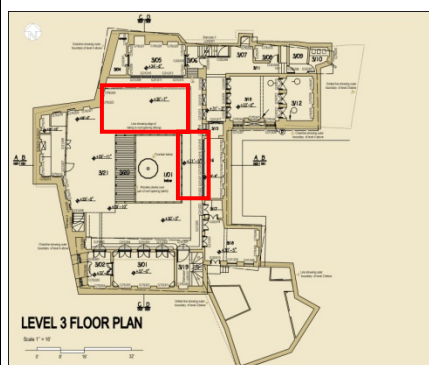
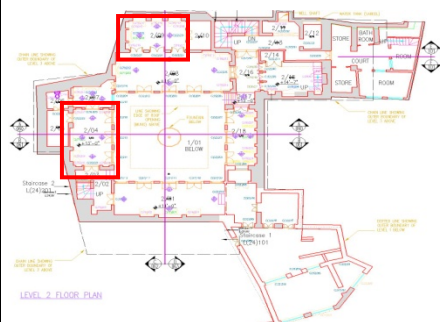
2.2 Drawings

2/04: Preparation of Wood Pieces for Terseem Bandi in the Missing portions.
2/09: Fixing of wood pieces to complete the Terseem Bandi in missing portion.
3/01: Scrapping of doors to remove paint layers and to expose the original layer of wood.
3/21D: Cleaning the spaces and fixing new wood logs to re-strengthen the weaker corner of 3//21C& D and capping the Spaces with bricks and planks, applied anti-termite, spread polyethylene sheet, and lime mortar.
Anti-termite, bricks, polyethylene sheet and lime mortar layers in the part C.
4/01: Clearing the space to erect the wood railing.

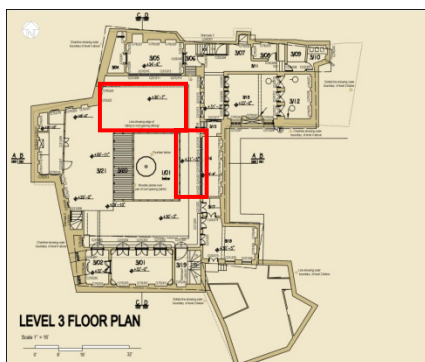
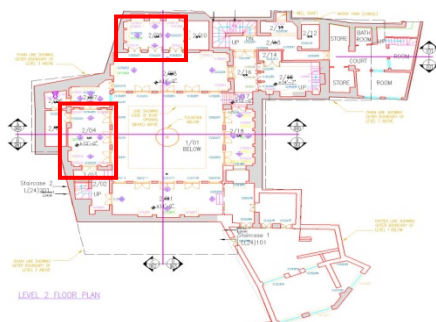
2.2 Drawings

2/04: Preparation of Wood Pieces for Terseem Bandi in the Missing portions.
2/09: Fixing of wood pieces to complete the Terseem Bandi in missing portion.
3/01: Scrapping of doors to remove paint layers and to expose the original layer of wood.
3/18: Fixing new wood pieces to repair the false ceiling.

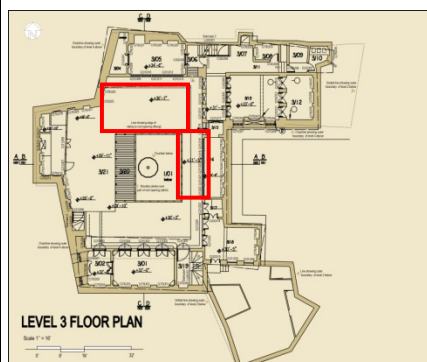
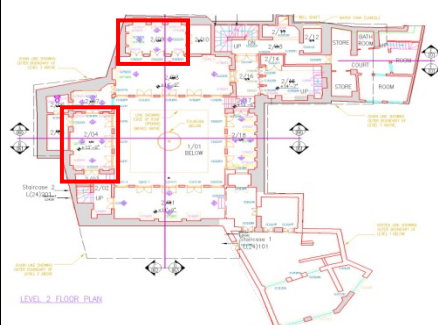
2.2 Drawings

2/04: Preparation of Wood Pieces for Terseem Bandi in the Missing portions.
2/09: Fixing of wood pieces to complete the Terseem Bandi in missing portion.
3/01: Scrapping of doors to remove paint layers and to expose the original layer of wood.
3/18: Fixing new wood pieces to repair the false ceiling.
2/07: Fixing New Wood Pieces in the Terseem Bandi.
Steel Wire loop is fixed according to the instruction of Mr. Amin Tariq.

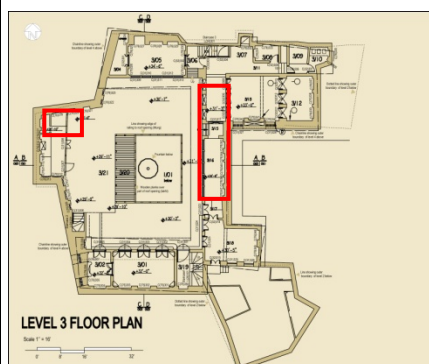
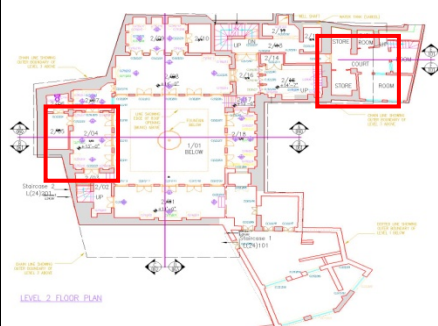
2.2 Drawings

2/04: Preparation of Wood Pieces for Terseem Bandi in the Missing portions.
2/05: Preparation and fixing of wood pieces to complete the Terseem Bandi in missing portion.
3/01: Scrapping of doors to remove paint layers and to expose the original layer of wood.
3/16: Removing the Brick Layer of Flooring and shifting the melba outside the House.
S.Q: Steel Wire loop tied according to the instruction of Mr. Amin Tariq.

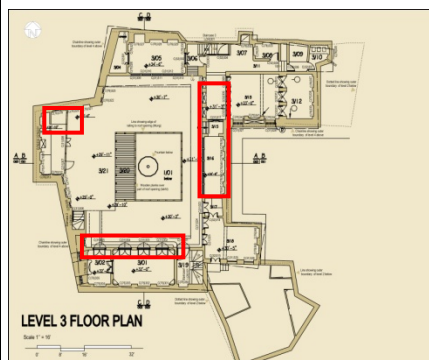
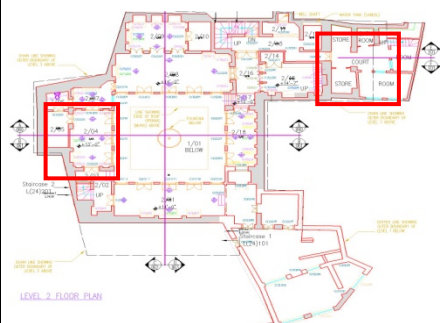
2.2 Drawings

2/04: Preparation of Wood Pieces for Terseem Bandi in the Missing portions.
2/05: Preparation and fixing of wood pieces to complete the Terseem Bandi in missing portion.
3/01: Scrapping of doors to remove paint layers and to expose the original layer of wood.
3/16, 15, 14: Removing the Brick Layer of Flooring and shifting the melba outside the House.
S.Q: Steel Wire loop tied according to the instruction of Mr. Amin Tariq, but he doesn't look satisfied so looking more.

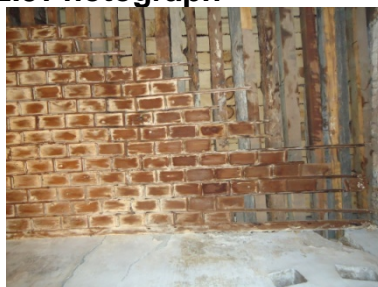
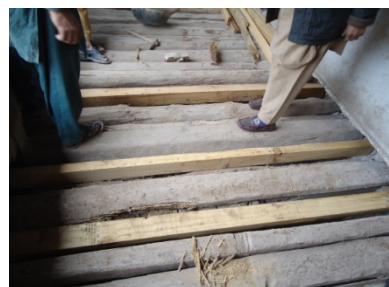
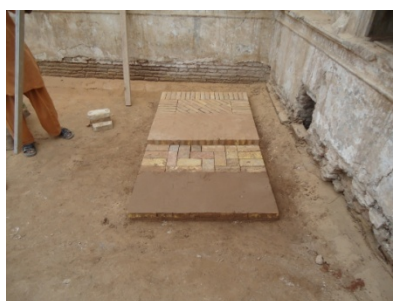
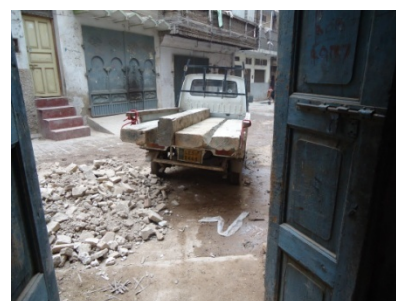
2.3 Photograph

2/04: Preparing Wooden Gola for Terseem Bandi of Missing Portions.
2/05: Preparation and fixing of wood pieces to complete the Terseem Bandi in missing portion.
3/01: Scrapping of doors to remove paint layers and to expose the original layer of wood.
3/16, 15, 14: Cleaned and Replaced 4 rafters with new in 3/16, applied anti termite, spread polyethylene sheet and poured lime mortar according to the level.
S.Q: Steel Wire loop tied according to the instruction of Mr. Amin Tari, but he doesn't look satisfied so looking more.

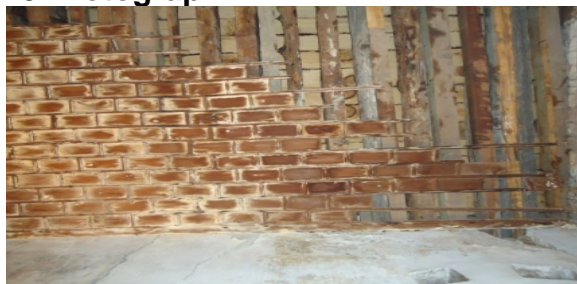
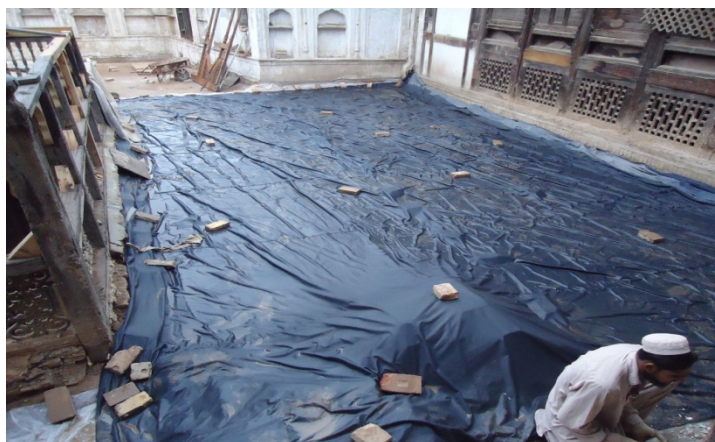
2/04: Preparing Wooden Gola for Terseem Bandi of Missing Portions.
2/05: Preparation and fixing of wood pieces to complete the Terseem Bandi in missing portion.
3/01: Scrapping of doors to remove paint layers and to expose the original layer of wood.
S.Q: Steel Wire loop tied according to the instruction of Mr. Amin Tariq, but he doesn't look satisfied so looking more.

2/04: Preparing Wooden Gola for Terseem Bandi In the Missing Portions.
2/05: Preparing and Fixing of wood pieces in the missing portion of Terseem Bandi.
3/21: Protect the Area from Heavy Rain.
S.Q: Steel Wire Loop.

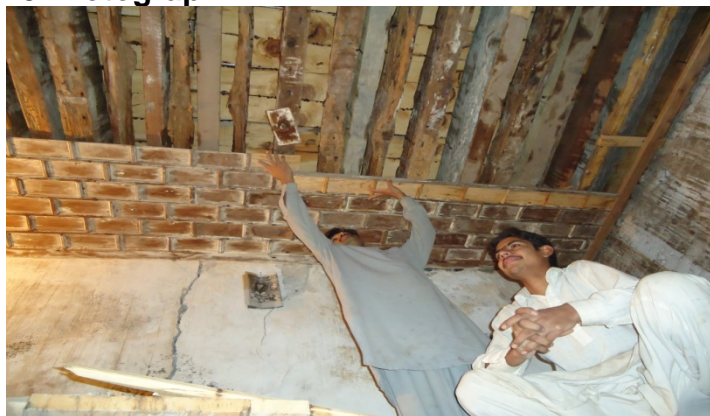
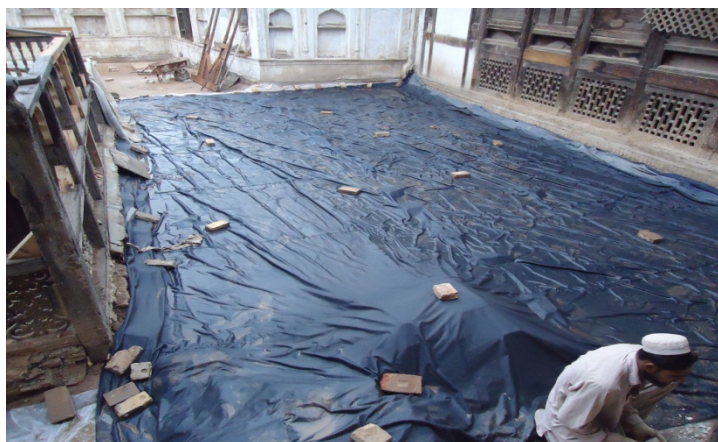
2/04: Preparing Wooden Gola for Terseem Bandi of Missing Portions.
2/05: Preparation and fixing of wood pieces to complete the Terseem Bandi in missing portion.
3/01: Scrapping of doors to remove paint layers and to expose the original layer of wood.
3/18: Lime Plaster repair started in the room.
S.Q: Steel Wire loop tied according to the instruction of Mr. Amin Tari, but he doesn't look satisfied so looking more.

2/04: Preparing Wooden Gola for Terseem Bandi In the Missing Portions.
2/05: Preparing and Fixing of wood pieces in the missing portion of Terseem Bandi.
3/21: Protect the Area from Heavy Rain.
3/18: Lime Plaster
S.Q: Steel Wire Loop.

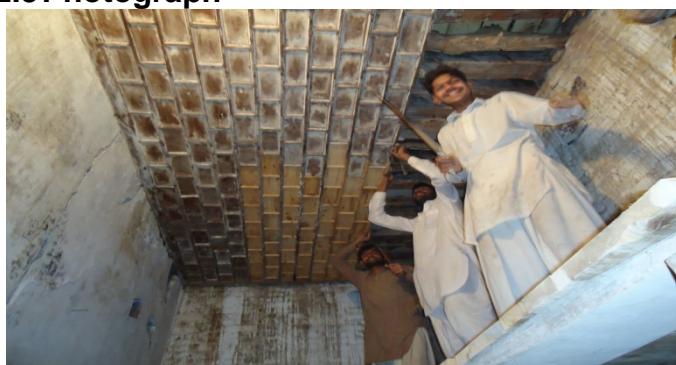
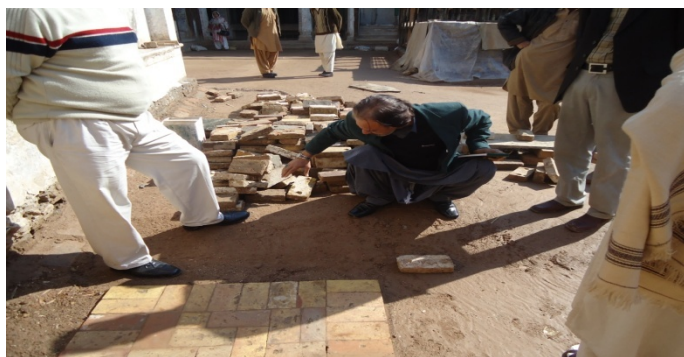
2/04: Preparing Wooden Gola for Terseem Bandi of Missing Portions.
2/05: Preparation and fixing of wood pieces to complete the Terseem Bandi in missing portion.
3/01: Scrapping of doors to remove paint layers and to expose the original layer of wood.
3/05: Removing of flooring layers 2"x4"x8" brick, 1.5" Lime Mortar, 3"Mud.
S.Q: Steel Wire loop tied according to the instruction of Mr. Amin Tari, but he doesn't look satisfied so looking more.

2/04: Preparing Wooden Gola for Terseem Bandi In the Missing Portions.
2/05: Preparing and Fixing of wood pieces in the missing portion of Terseem Bandi.
3/18: Lime Plaster
3/05: Removing of roof Layers.
4/01: Re-install of upper beam of the railing.
S.Q: Steel Wire Loop.

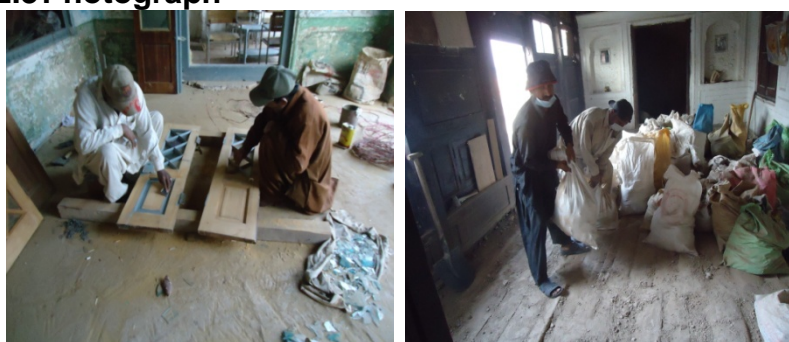
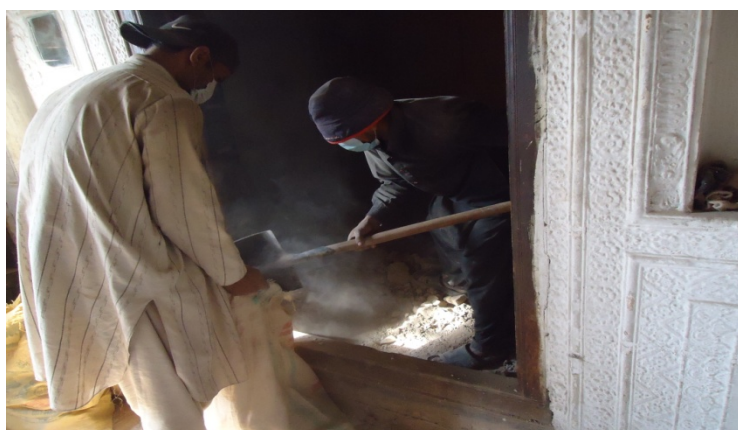
4/01: Started erecting scaffolding for the restoration of cornice.

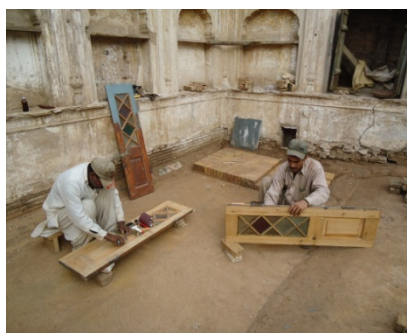
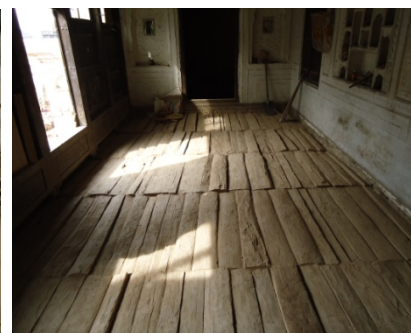
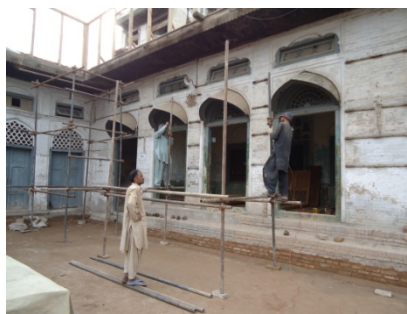
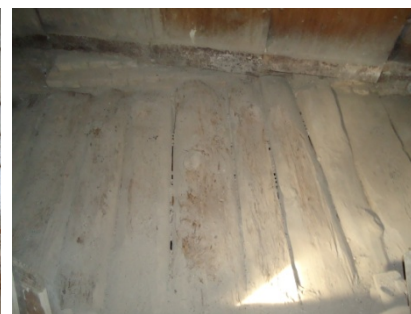
2.3 Photograph

3/04: Removed flooring layers 2"x4"x8" brick, 1.5" Lime Mortar, 3"Mud and found 4th, 6th, 7th rafters were dilapidated and Required to be replaced.

4/01: Started erecting scaffolding for the restoration of cornice and terseem bandi of sun shade.

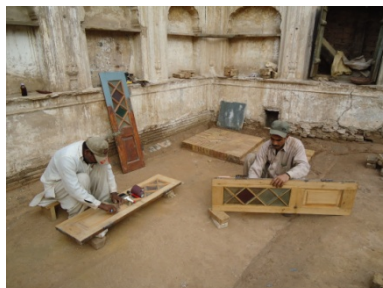
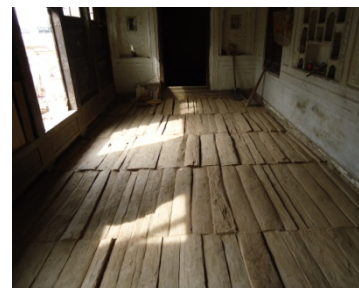
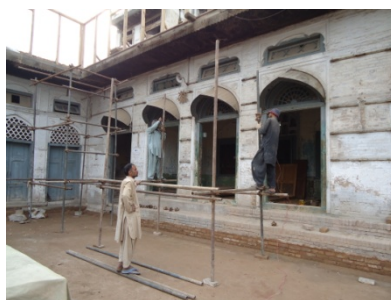
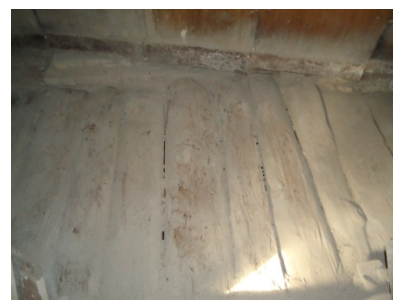
2.3 Photograph

4/01: Started erecting scaffolding for the restoration of cornice.

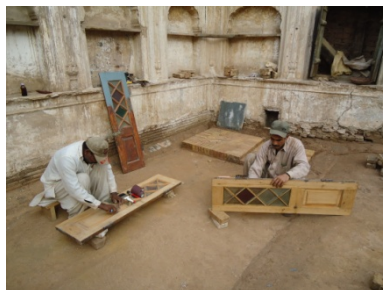
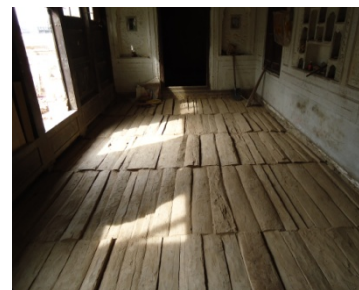
2.3 Photograph

4/01: Started erecting scaffolding for the restoration of cornice.

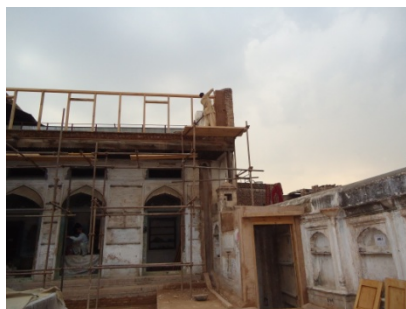
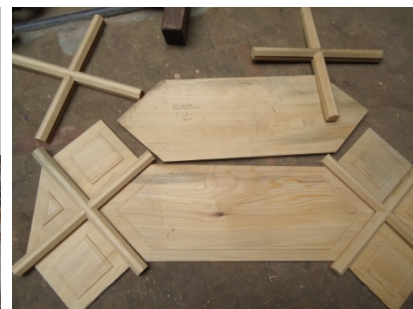
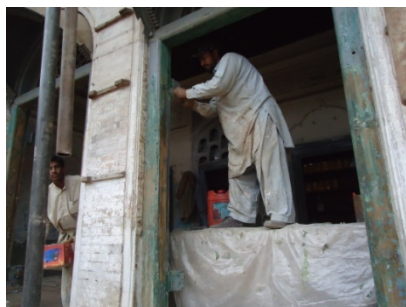
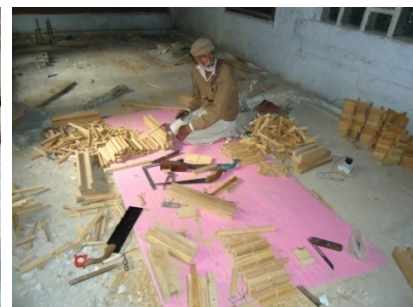
2.3 Photograph

3/04: Treating the cracks appeared in the newly Mortar flooring layer.

4/01: Erecting the scaffolding for re-construction of cornice and repair sun shade.

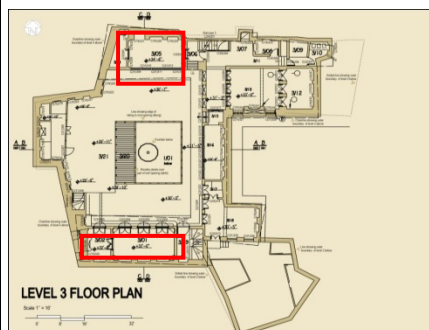
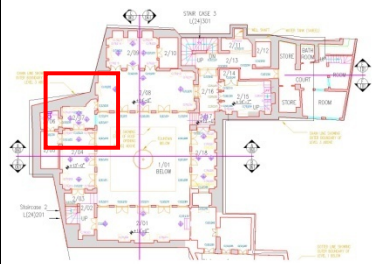
2.2 Drawings

-1/04: Removing the flooring Layers 2" bricks, 2" White Lime and Mud 12".
2/04: Preparation of wooden gola joints and erected scaffolding for terseem bandi in the missing portion.
3/01, 02: Removing of paint layers from doors and cupboard to expose the original grains/layer of wood
3/21: Mung, Wood Screen Repair Started and Flooring preparation continues.
4/01: Re-construction of cornice and repair sun shade continues.
S.Q: Enclosed the red zone with Steel Wire Loop to avoid any mishap.

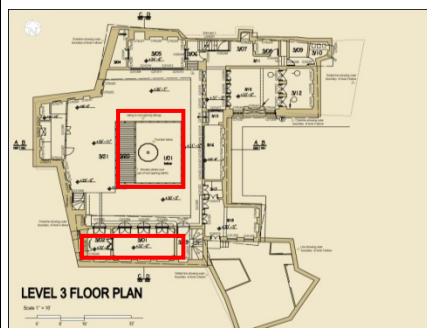
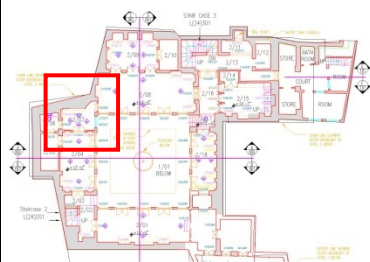
2.2 Drawings

-1/04: Removing the flooring Layers 2" bricks, 2" White Lime and Mud 12".
2/04: Fixing of new wood pieces in the border to complete the missing portion terseem bandi.
3/01, 02: Removing of paint layers from doors, cupboard and ventilators to expose the original grains/layer of wood
3/21: Mung, Wood Screen Repair Started and Flooring preparation continues.
4/01: Re-construction of cornice and repair of sun shade continues.
S.Q: Decided to Enclosed the red zone with Steel Wire Loop by the Structural Engineer to avoid any mishap.

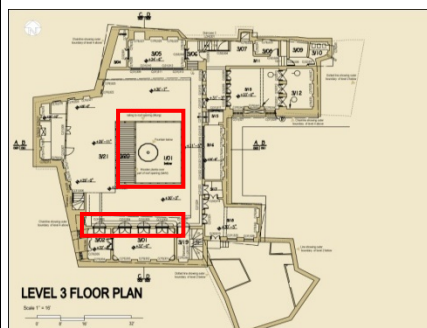
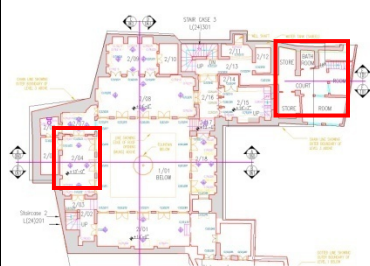
2.2 Drawings

-1/05: Removing the flooring Layers 2" bricks, 2" White Lime and Mud 12".
2/04: Fixing of new wood pieces in the border to complete the missing portion terseem bandi.
3/03: Lime plaster repairing on the walls up to dado level.
3/01, 02, 19: Removing of paint layers from doors, cupboard and ventilators to expose the original grains/layer of wood
3/21: Mung, Wood Screen Repair, and Flooring preparation continues.
4/01: Re-construction of cornice and repair of sun shade continues.
S.Q: Enclosed the red zone with Steel Wire Loop by the Structural Engineer to avoid any mishap.

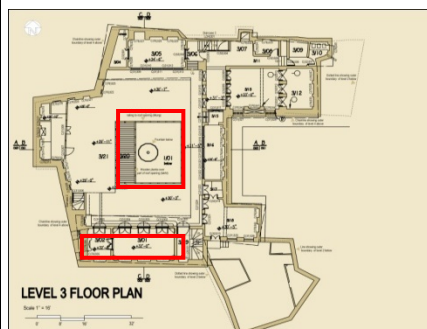
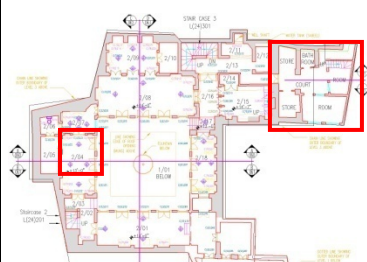
2.2 Drawings

-1/06: Removing the flooring Layers 2" bricks, 2" White Lime and Mud 12".
2/04: Fixing of new wood pieces in the border to complete the missing portion of terseem bandi.
3/01, 02, 19: Removing of paint layers from doors, cupboard and ventilators to expose the original grains/layer of wood
3/21: Mung, Wood Screen Repair Started and Flooring preparation continues.
4/01: Re-construction of cornice and repair of sun shade continues.
S.Q: Enclosed the red zone with Steel Wire Loop by the Structural Engineer to avoid any mishap.
