Federal Republic of Germany Tomb of Jan Baba at WHS Makli, Thatta Progress Report No - 2015/001

January, 2015

Federal Republic of Germany Tomb of Jan Baba at WHS Makli, Thatta Progress Report No - 2015/003

Progress Report No - 2015/004

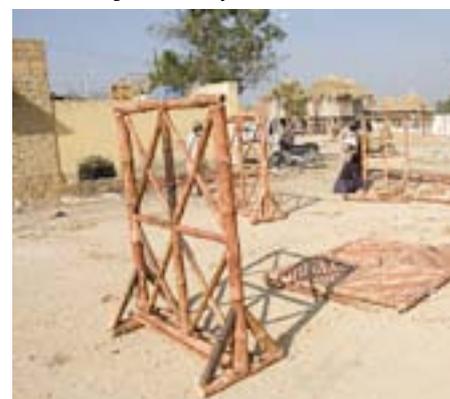
Fabrication of free standing bamboo barriers

- Heritage Foundation Artisans fabricated free standing bamboo barriers that would fill the openings. These barriers were manufactured with care, so as not to harm any of the carved stone or ornamentation of the tomb.

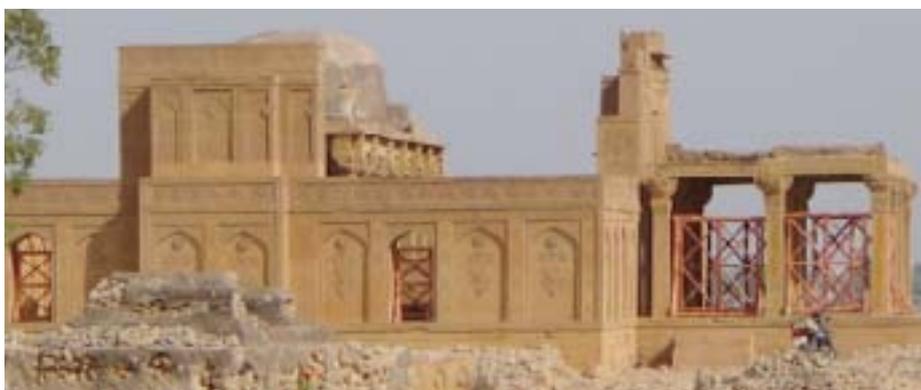
Installed bamboo barriers

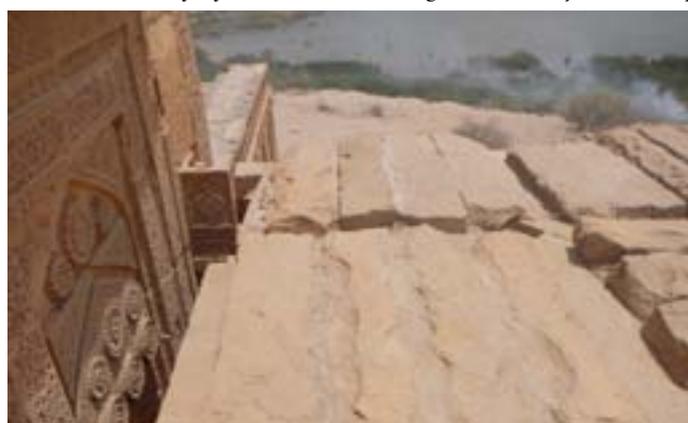
For this purpose levels of the roof were determined by taking water levels. It appeared that the not only water was dripping through due to holes in the top

Documenting the roof of the Entrance veranda

surface, the water was being discharged in the space between the enclosure wall and the canopy edge, which could not easily be drained, while some rain-water would be lodged in the canopy roof due to lack of drainage.. An alternative arrangement for discharging water from the canopy has been worked out in order to provide effective disposal of rain water.

- Matching lime sand water proof layer to be applied to damaged surfaces of stones above the entrance canopy. Proper drainage should be maintained to discharge on east side.

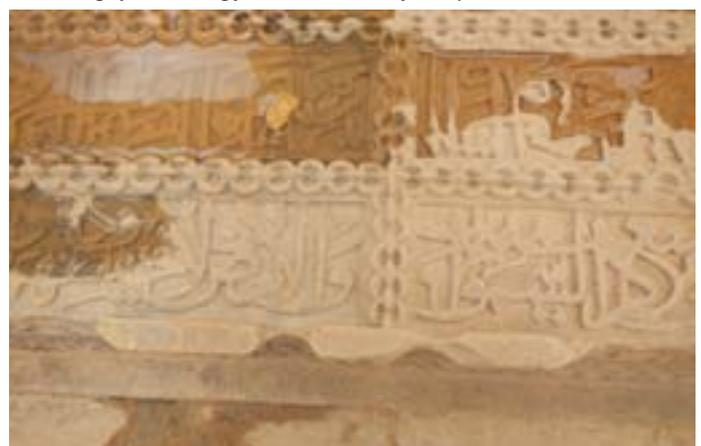
Wet cleaning of graves.

- Wet Cleaning of graves was done carefully using only water and soft brushes. Great care was taken to avoid brushing hard against the carvings.

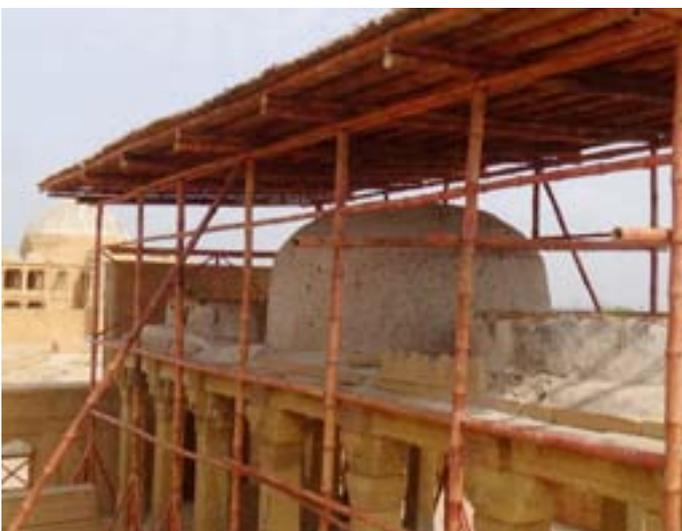
- The graves platform has been secured with a temporary bamboo roof structure. The structure provides protection from the upcoming monsoon season, it is made sure that no further damage is caused to the graves canopy. The structure has been stabilized with toe like supports at the bottom.

Roof structure over the Graves Canopy.

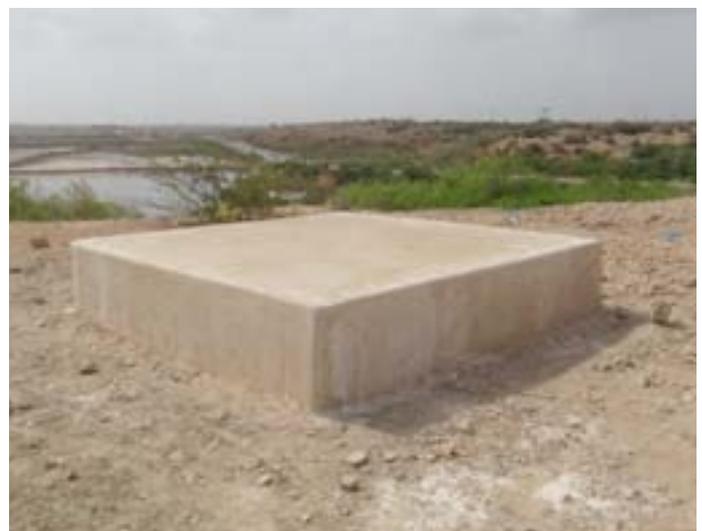
- It was noted that there are many stones scattered around the periphery of the tomb. Hence a platform was constructed near the tomb to secure these historic stones. The platform allows for the stones to be above the ground in anticipation of the upcoming monsoon season.

Platform to secure the loose stones from Jan Baba

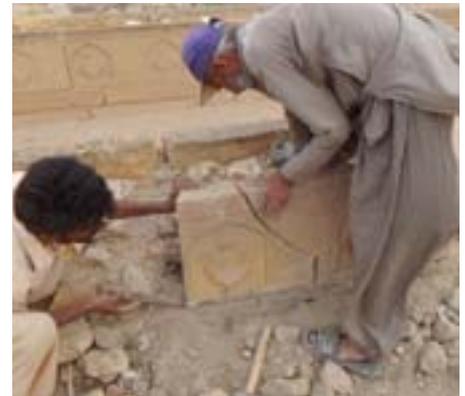
Placing fallen stones along the pathway.

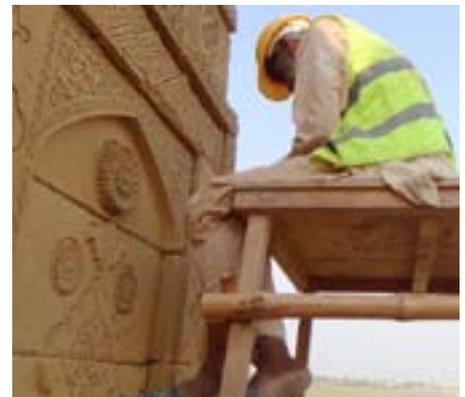
Pointing on the exterior facade of the Tomb.

- Sample of deep struck re-pointing was approved to be used on joints of 1/4" to 3/8" thickness.
- The principle of minimum interventions is to be adopted; no stone replacement to be carried out.

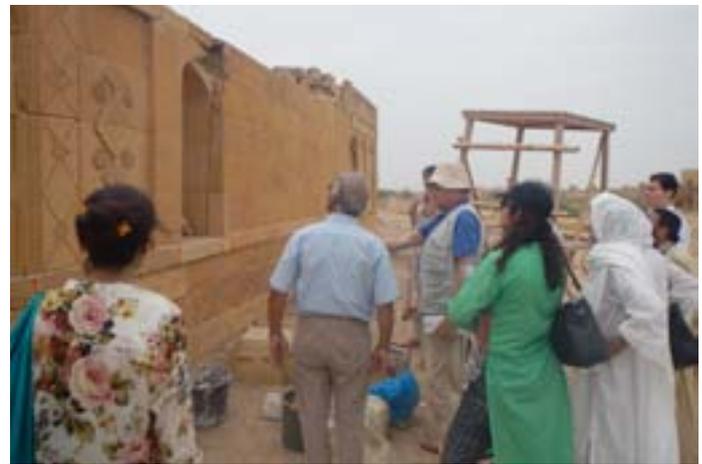
Prof. Dr. Michael Jansen, discussing the usage of types of stone in walls.

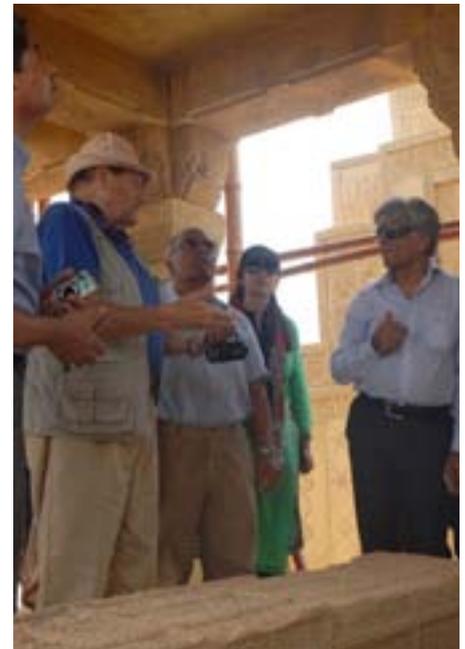
The condition of graves under discussion.

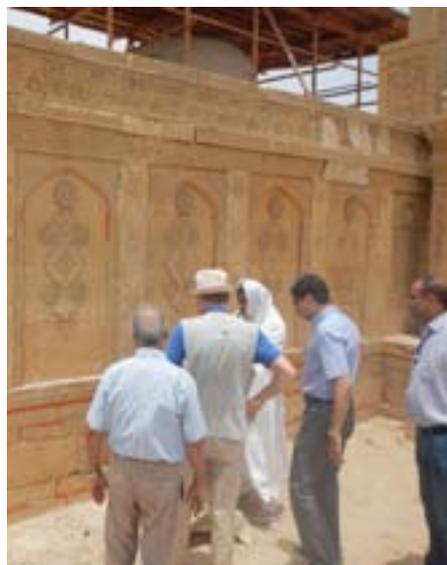
Discussion regarding identification of stone types.

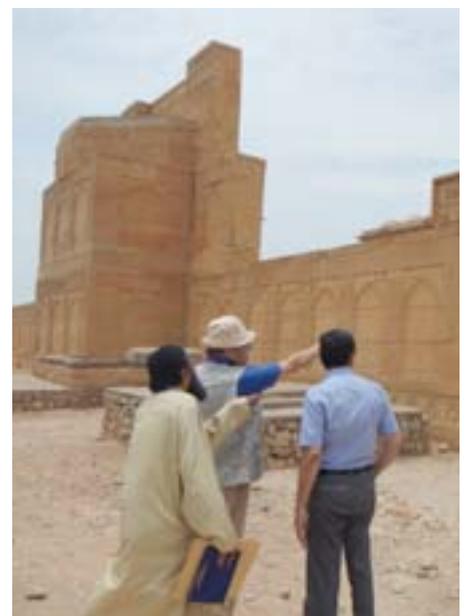
Enclosure walls being discussed.

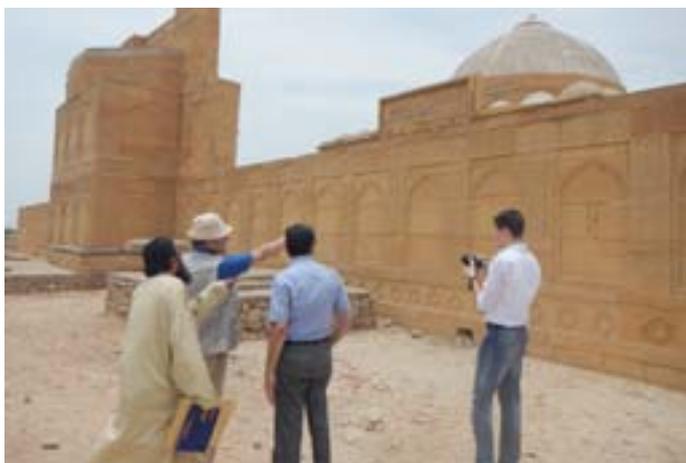
Studying the enclosure walls.

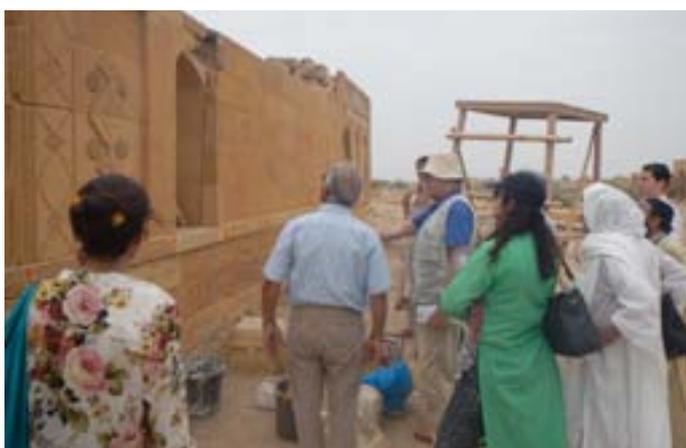
Examining the perimeter wall panels.

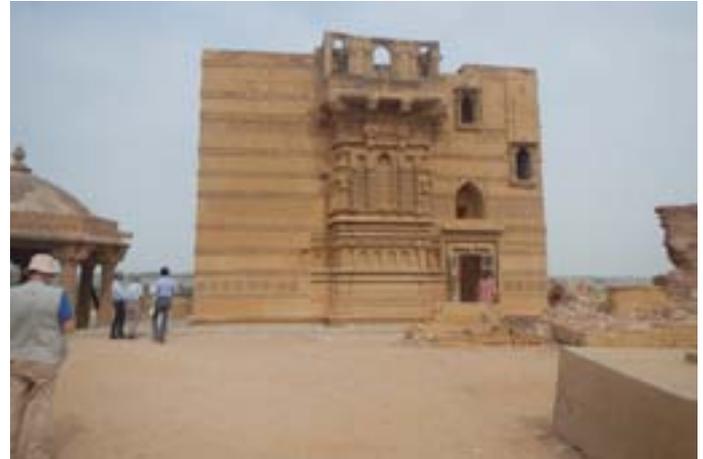
The engineering experts explained that the ridge required stabilization and it was constantly being eroded. Unless immediate action was taken, many structures, including the tomb of Jam Nizam al-Din were in danger.

Tomb of Jam Nizam al-Din under discussion.

Ar. Yasmeeen Lari agreed to get track monitors installed in order to monitor the movement in the structure, which she directed will be done in the subsequent week.

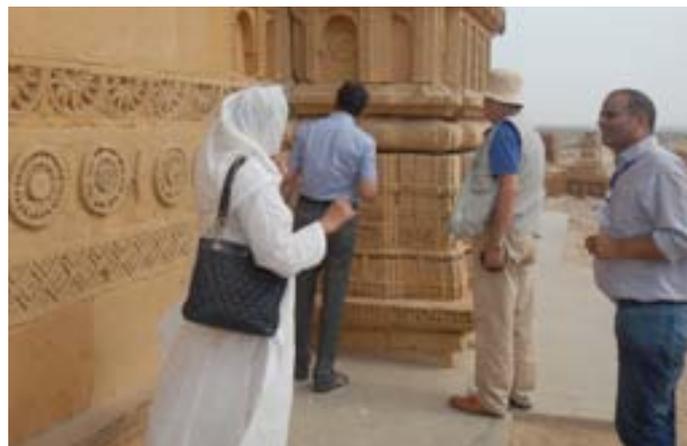
Discussion on installation of crack monitor.

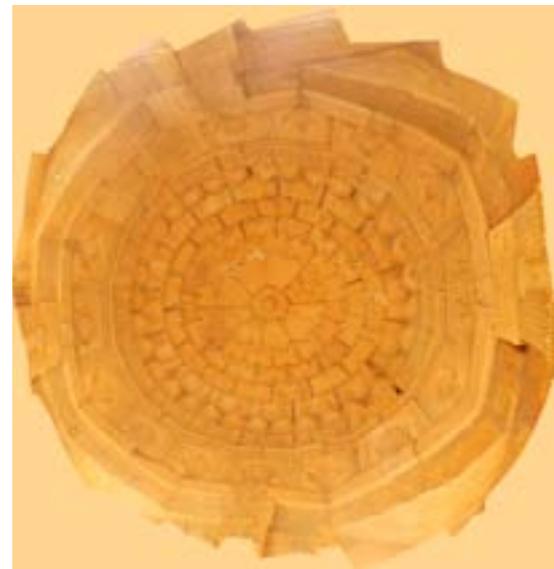
As highlighted in various reports prepared by HF, the central dome was in a highly vulnerable condition and it was agreed that it needed to be stabilized urgently. The Experts' Committee provided clear directions to maintain the original structure even though deformation had taken place within the dome structure as well as supporting stone joists and pillars. It was agreed that after stabilizing the dome, regular monitoring should be carried out in order to determine any movement in the structure.

View of soffit of central dome.

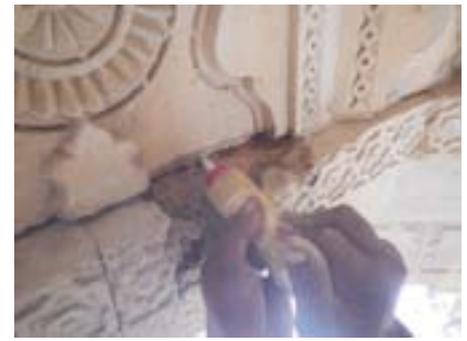
Injecting Lime Mortar into deep joints

- The discussion of the filling of masonry joints led to the decision that the wide and the narrow stone masonry joints should be treated in different ways.
- It was discussed that the narrow joints will be filled in through and through by injecting mortar into the joints using a household icing gun. These will be re-pointed after filling.
- The wide joints were considered separately and first the option of inserting a stone piece to fill in the gaps was considered. It was then discussed that whether the new stone filling be of different color, whether it should follow the same cusped shape of the historic stones, should it be marked with the year of intervention and other conservation concerns.
- The difficult workability of the stone to carve in the precise shape was discussed as a point of concern.

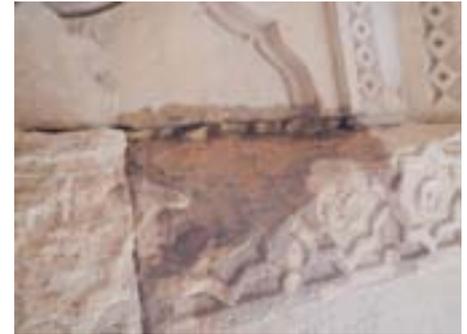
First layer of injected mortar

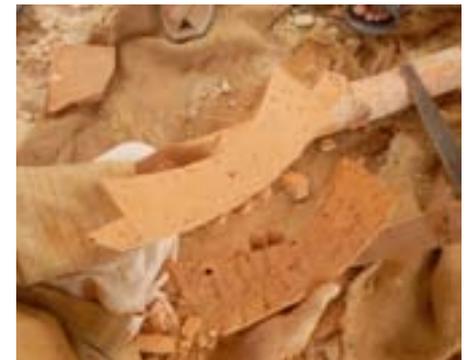
Preparing terracotta piece for filling..

- By using brick the difference of material along with its different color will conveniently mark the new conservation work, with 2015 marked in an unobtrusive manner on one of the brick insertions.
- The workability of brick is easier than the stone and the skilled master artisans available with HF will be able to carve the brick into the required shape on site.
- This material will be stronger than mortar and less likely to develop cracks upon any movement / settlement.
- The brick will not be as strong as the original material (stone) as is preferred for new conservation work.
- The weight of brick will be less than the stone filling and hence no extra weight will be put on the dome.

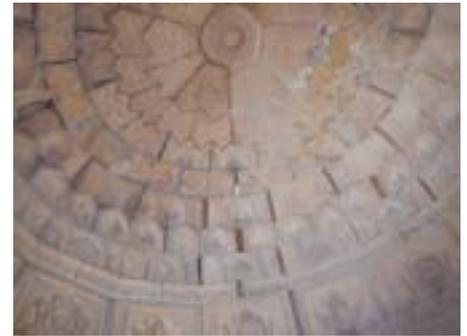
North East Section after Brick underpinning

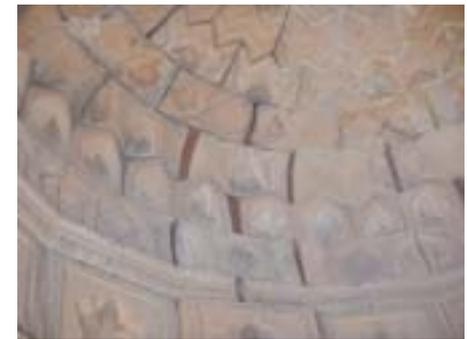
North section after stabilization.

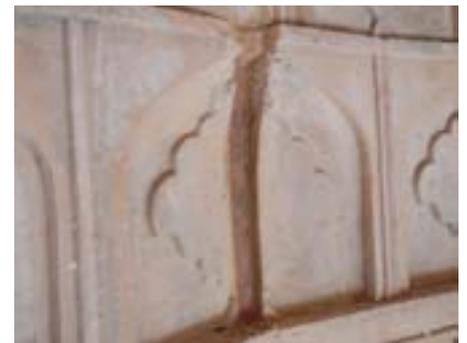
Close-up of the terracotta piece profiled to fit in the gap.
